Carter Ground Fueling Division
Argo-Tech Corporation - Costa Mesa

**APPLICABLE TO ALL CARTER API STYLE
HYDRANT COUPLERS***

**PN700092705
Revised May 26, 2006**

EXCESSIVE WEAR CAN CAUSE COUPLER EJECTION

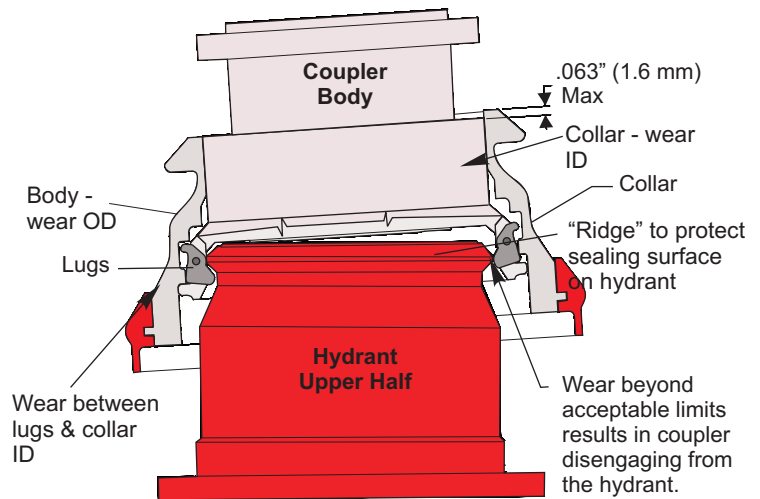
FIGURE 1 - RESULTS OF WEAR ON COUPLER/HYDRANT INTERFACE

- The internal wear mainly between the collar and the lower housing was found to be extreme. A closer investigation into this situation was conducted to determine the results of the wear on these internal surfaces and also to aid in the development of additional inspection tests that can be recommended to determine the end of the useful life of the coupler components. The latching lug wear was less severe, indicating that the lugs may have been replaced (possibly several times) during earlier overhauls.

Figure 1 (top right) shows the results of an excessively worn Coupler and how the collar shifted from the centerline and rotated around the lugs directly opposite the operating handle. The surface where the collar ID contacts the coupler body OD must be excessively worn for this to occur. This rotation results in the Collar lifting on one side (directly opposite the operating handle) .100 of an inch (2.5 mm) or more when the coupler is pressurized. When the Collar is lifted, the latching lugs become partially unsupported and the lugs start rotating toward the disengaged position. The lugs are made of 7075-T6 aluminum with an ultimate strength of 83,000 psi, and the collar is a casting made of 356-T6 aluminum with an ultimate strength of 30,000 psi. As pressure increases the lugs (being stronger) rotate and deform the internal ring in the collar until the collar is lifted to the full disengaged position and the coupler separates from the hydrant valve.

RECOMMENDATION The following procedure should be incorporated into your maintenance program for all Carter Couplers (regardless of Coupler part number) and Hydrant Valves made to API/IP 1584 Specification:

1. Periodically use the 60554ST1 Gauge on all API style hydrant valves to determine whether the interface configuration is within acceptable wear limits. See the appropriate service manuals for instructions on its use. If the hydrant valve fails the 60554ST1 wear test, then the upper housing or replaceable API ring must be replaced.

2. DO NOT resurface or machine any of the surfaces on the interfaces on either the hydrant valve or the coupler. Removing material from these parts will increase clearances within the coupler/hydrant valve interface and make it more likely to result in a coupler ejection.

3. Periodically inspect all Carter Couplers for wear limits, as determined by the user. (Please note that the couplers that separated from the hydrant valves were over ten (10) years old and were excessively worn.) Quarterly inspections should be more than sufficient to identify possible problems well before the coupler wears beyond the safe useable limits.
