Service BULLETIN

**APPLICABLE TO 64348, 64349 & 64049
NOZZLES AS OUTLINED BELOW**

**SB3480801A
Nov. 1, 1998**

REVISION TO AUGUST 1, 1998 BULLETIN! NEW TWO-PIECE HANDLE BREAKAGE REPORTED

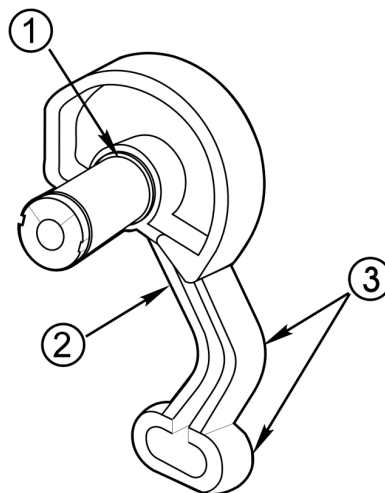
FIGURE 1

It has been reported that several of the newer 220878-1 handles have been broken on nozzles installed on hose reel applications. Reports of leakage from the handle shaft area were initial signs of breakage. Reports of the single screw coming loose were also signs of the breakage. The handle is an integral part of the nozzle interlock system. The breakage, result of mishandling (dropping), has occurred at a machined radius area “1”, as shown in Figure 1 on the next page. If not detected, further use can cause

the handle to loosen and overcome the interlock system. The result can then be a possible spill since it can then be possible for the operator to take the nozzle off of the aircraft with the nozzle poppet in the open position. The breakage has been the result of impact on the handle in the areas marked with a “3”, Figure 1. The handle first bends until it contacts the carrying handle or sometimes the bolt head attachment of it. The bolt head impact results in an impression in the handle and produces a stress riser in the area marked “2” which may result in the handle breaking at that point. This is a maintenance problem but not a safety issue. Further impacts in the areas marked “2” and “3” can result in the fracture at “1” which is the object of this bulletin. All operators should be provided the following information (instructions) to prevent spills and possible bodily injury from spilled fuel:

1. **No nozzles, to our knowledge, have had a handle breakage problem where they are installed on a deck type application; hence dropping is a major contributor to the problem. Even though it has been done in the past, another caution not to drop the nozzle should be extended to the operators.**
2. **If fuel leakage, no matter how slight, appears from the area of the operating handle do not use the nozzle. Take it out of service immediately. Inspect the handle for evidence of a crack at “1”. It may start out as a very minute crack and may be difficult to see with the eye. Replace the handle if not certain.**

If the handle or attaching screw appear to be loose, DO NOT ATTEMPT TO TIGHTEN THE SCREW, you will only cause the insert in the crank to be damaged. Remove the nozzle from service immediately.
